# ADVANCED METALLIC AIR VEHICLE STRUCTURE PROGRAM

SIXTH INTERIM REPORT

GENERAL DYNAMICS  
FORT WORTH DIVISION

TECHNICAL REPORT AFFDL-TR-76-74

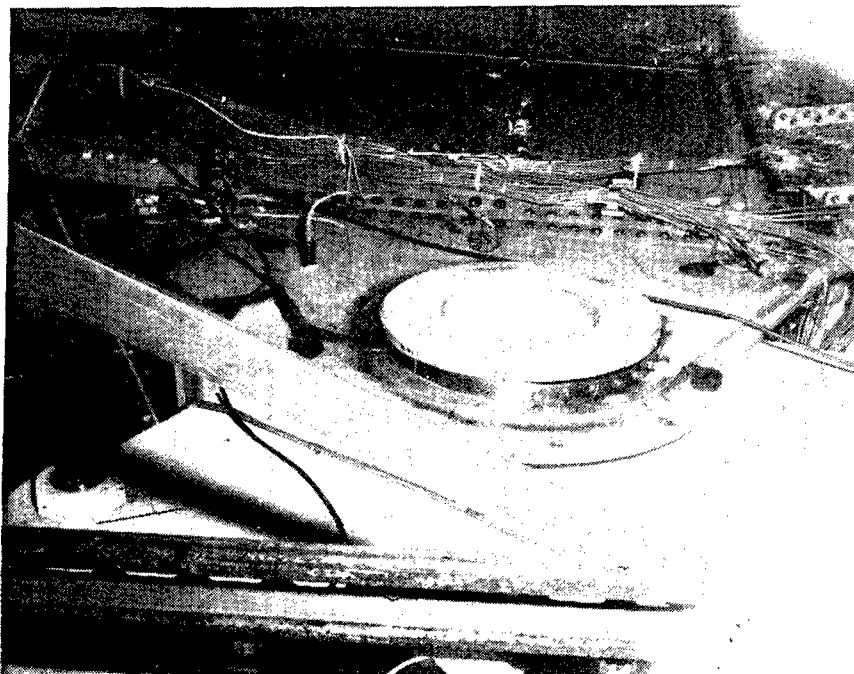
FIGURE 2.1.1-1

RETENTION OF UPPER BUSHING TO PIVOT PIN

Special wrenching mechanisms were designed to realign the pivot pins and lug bushings which rotated during the early stage of testing. Retaining systems were also designed to prevent recurrence of the rotation problem (See Figures 2.1.1-1 and 2.1.1-2). Repair procedures, hardware, tools, and supplies were planned and coordinated for replacement of broken fasteners, restoration of the pivot system, and retention of bolts experiencing repeated loosening.

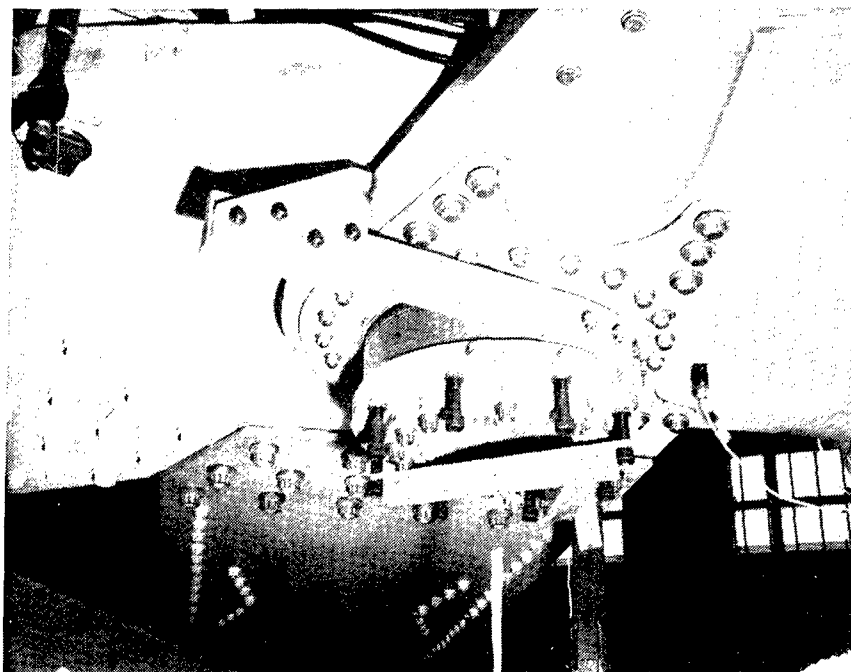
FIGURE 2.1.1-2

RETENTION OF LOWER BUSHING TO WCTS LOWER LUG

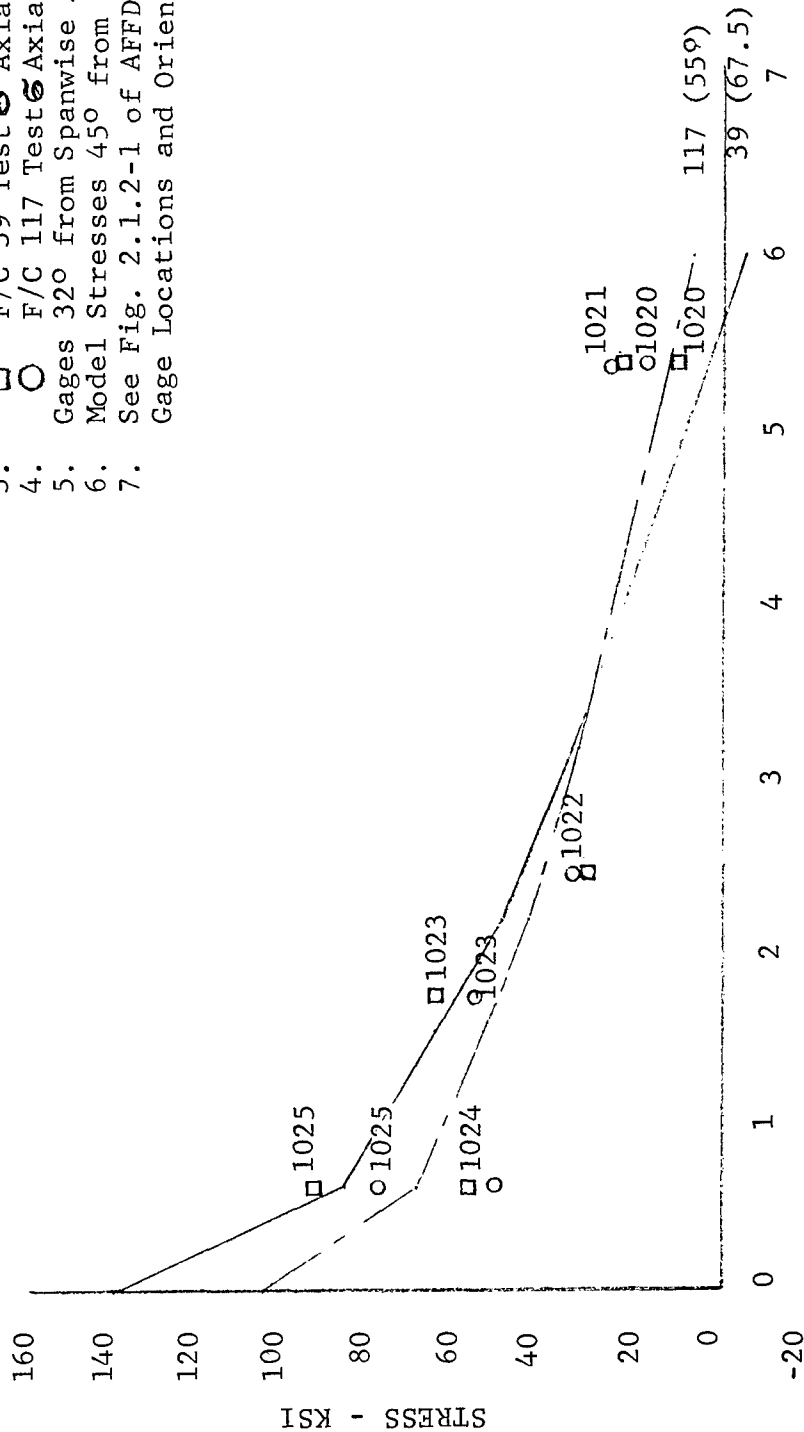
Figure 2.1.2-2

WCTS LOWER PIVOT LUG  
TYPICAL MEASURED AND PREDICTED STRESSES

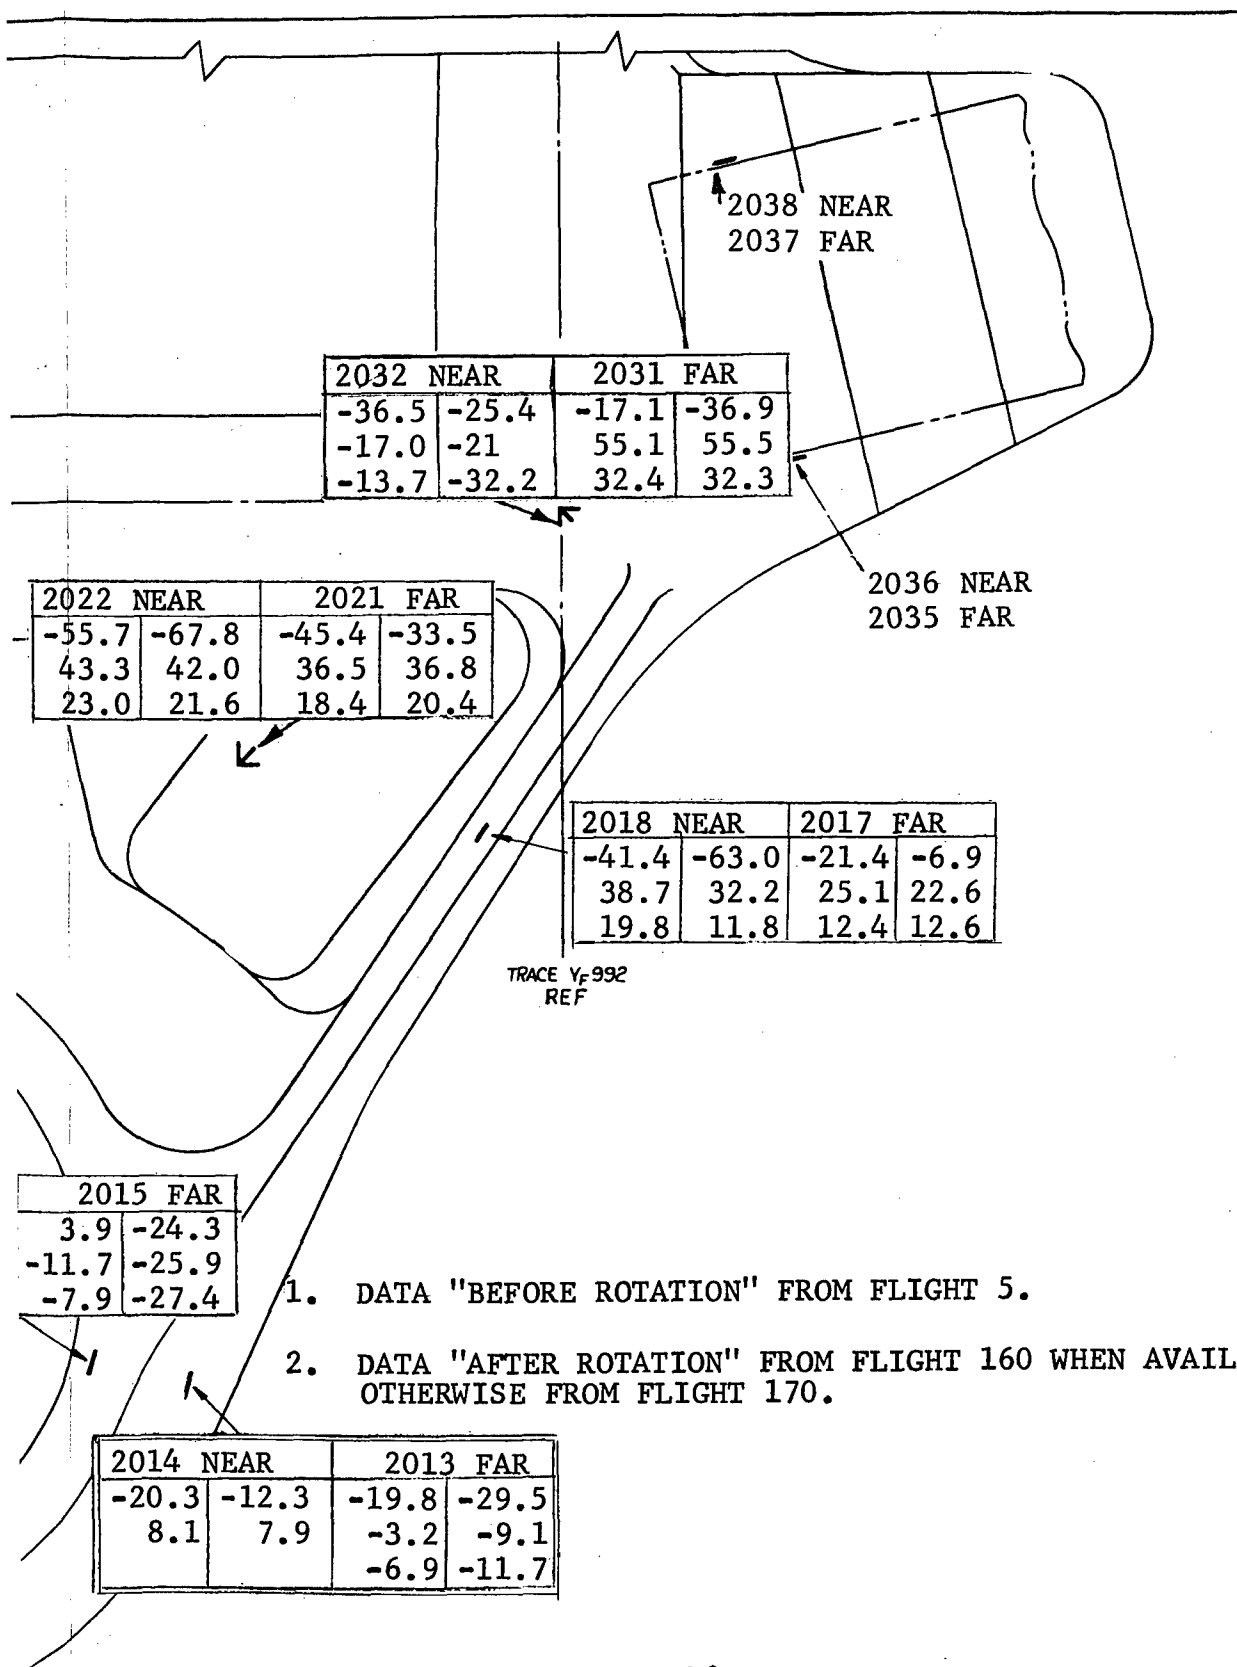
Figure 2.1.2-3

TYPICAL EFFECTS OF BUSHING ROTATION ON LUG STRESSES  
AMAVS UPPER LUG

However, the stress changes under load were considered to be indications that the obvious wedging caused by bushing rotation could adversely affect the fatigue life because of possible stress increases.

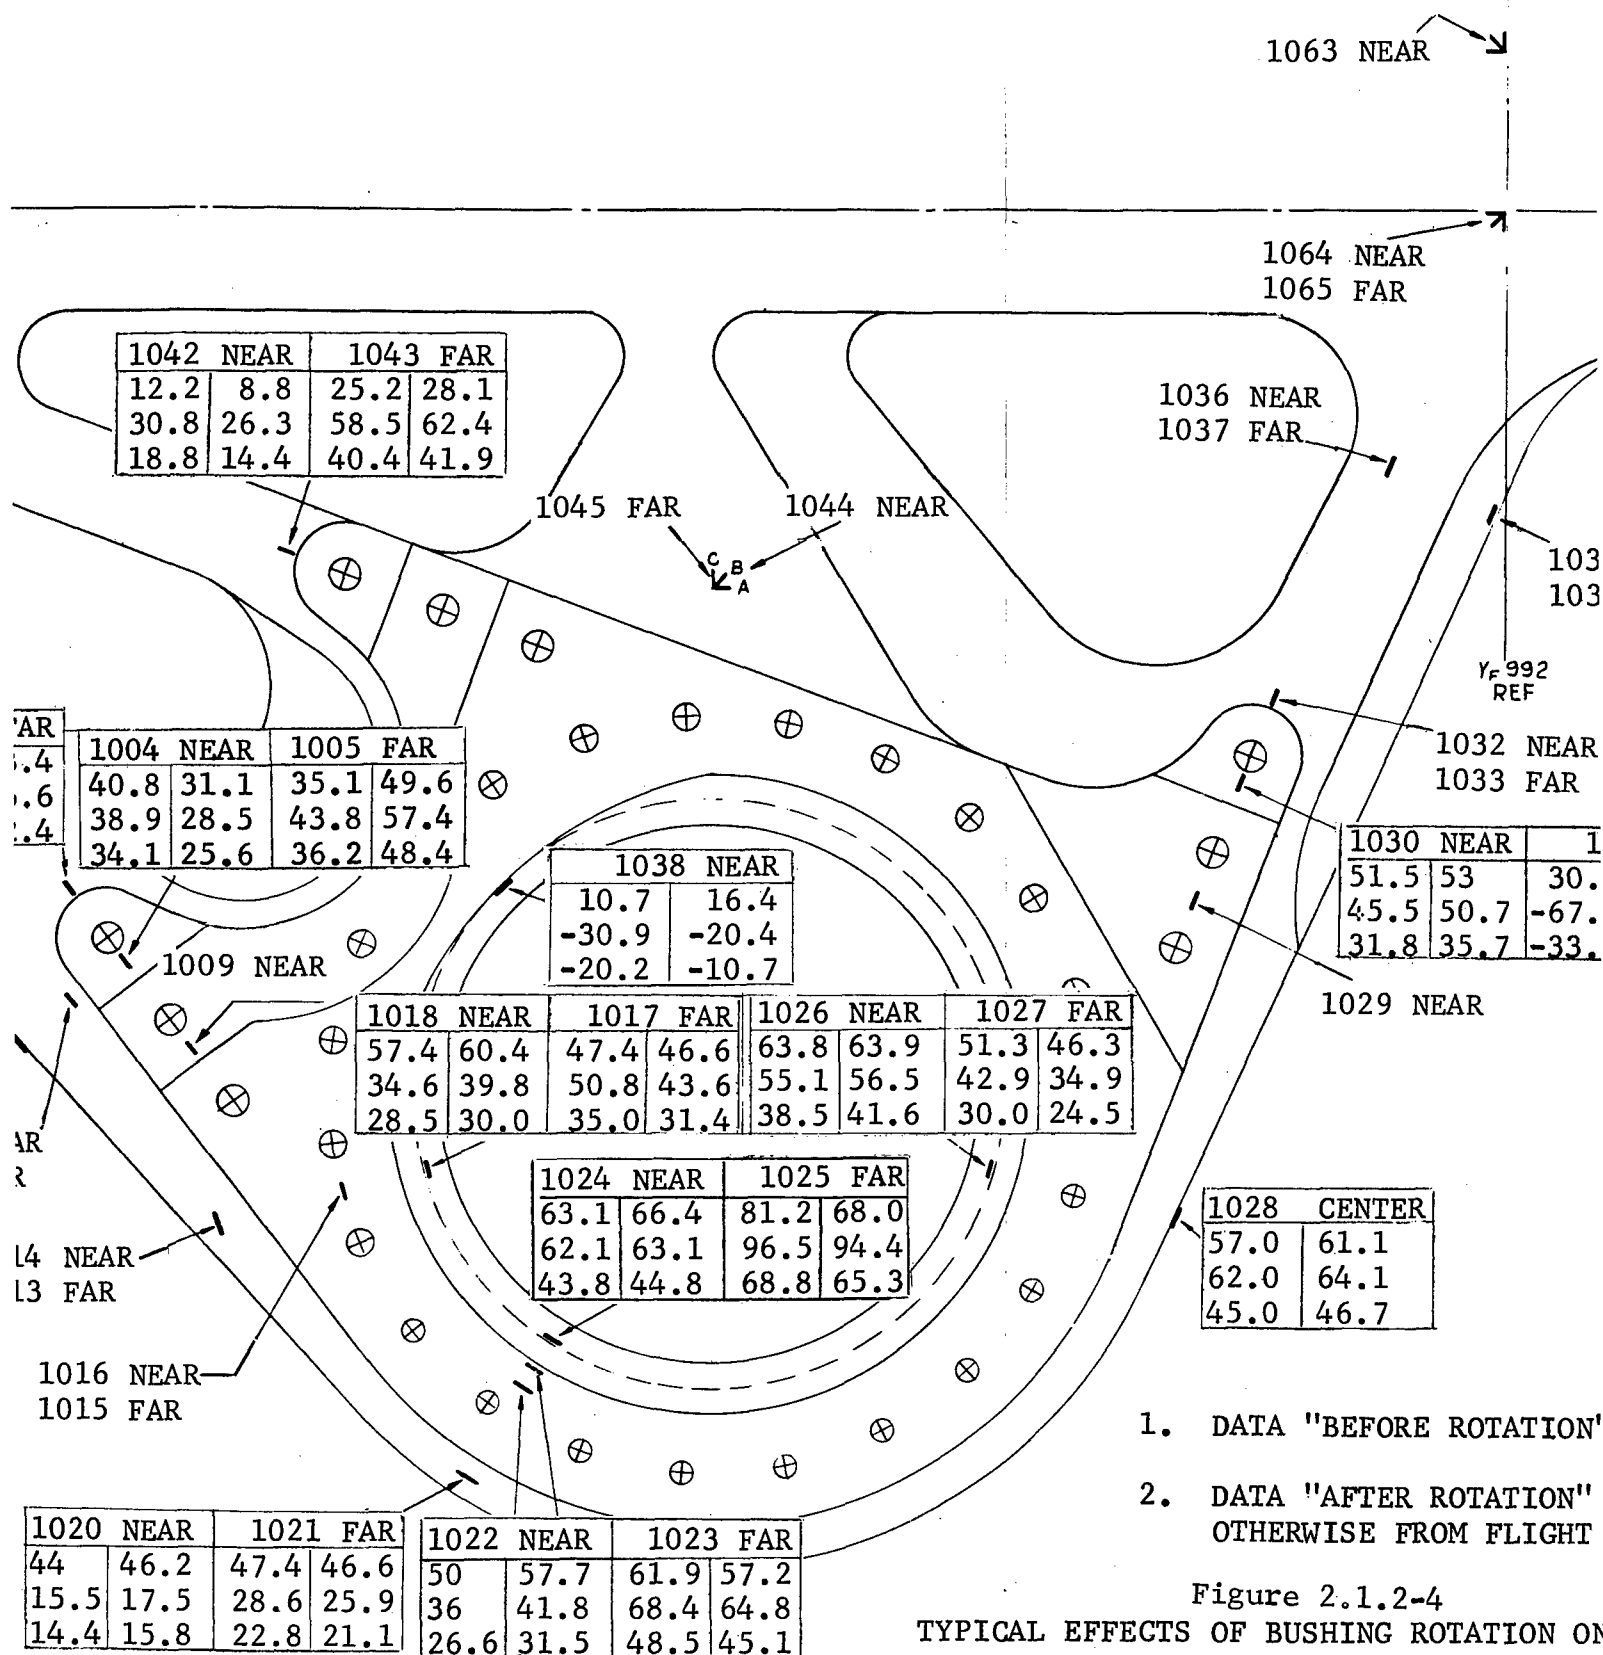
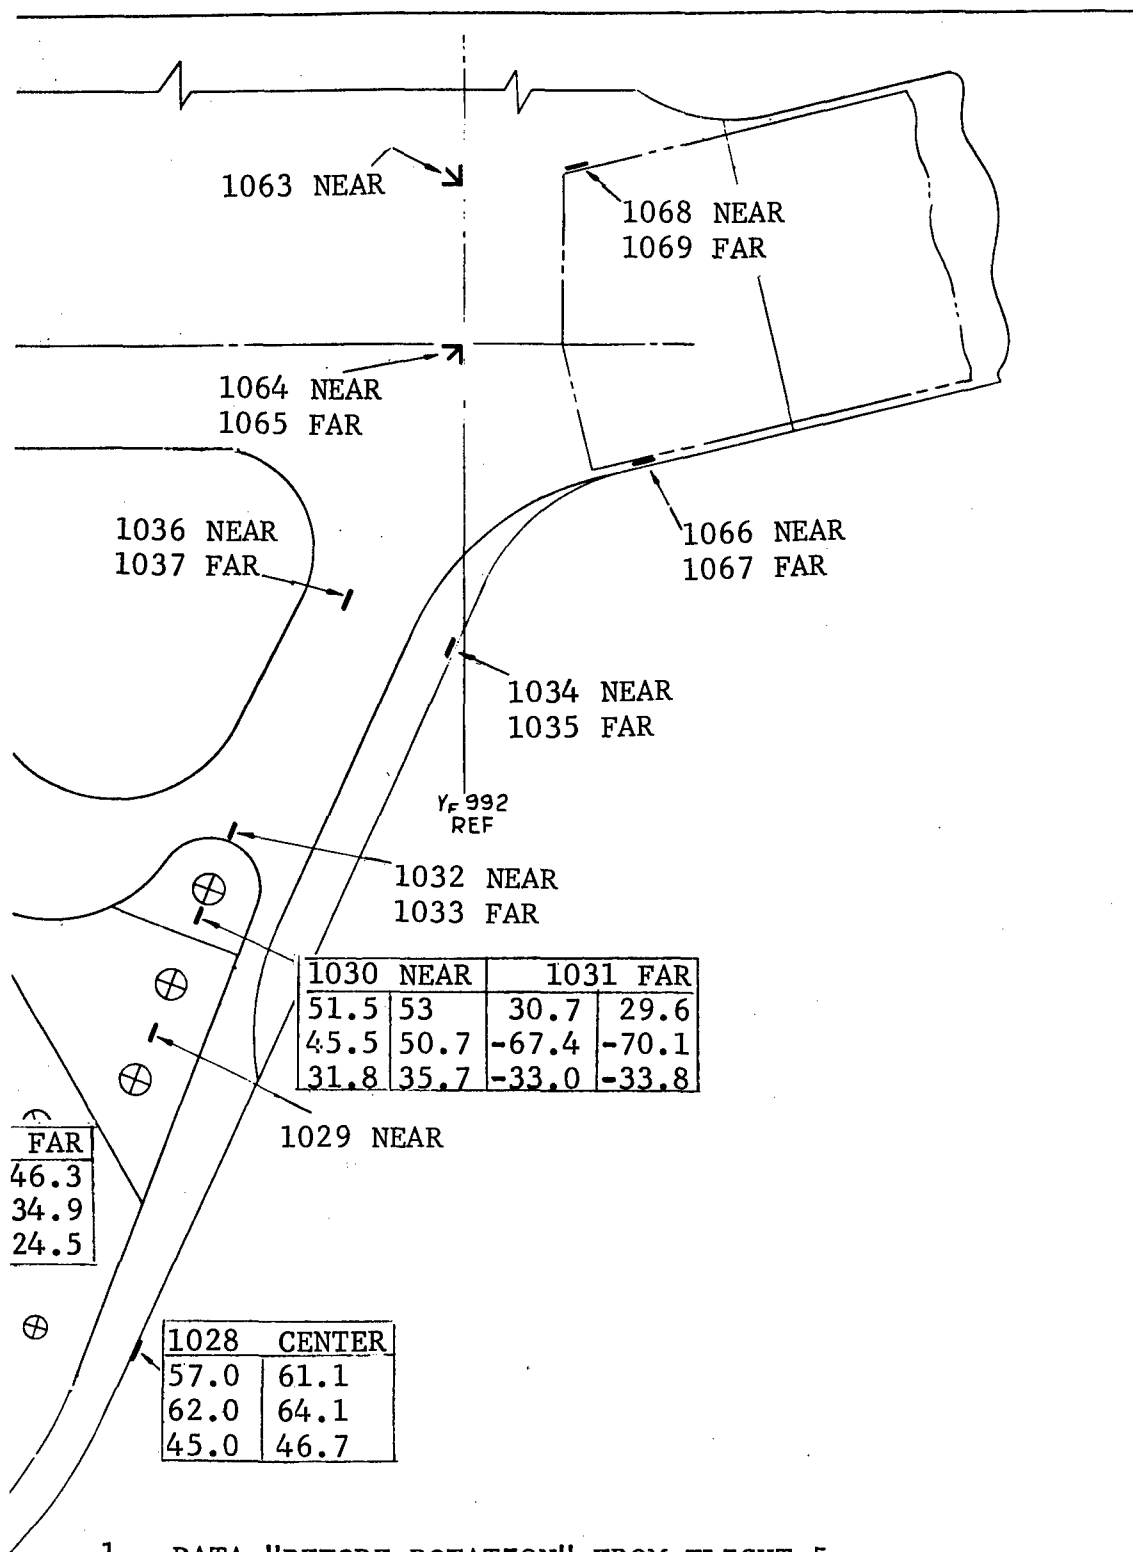
Figure 2.1.2-4  
EFFECTS OF BUSHING ROTATION ON LUG STRESSES  
AMAVS LOWER LUG

1. DATA "BEFORE ROTATION" FROM FLIGHT 5.
2. DATA "AFTER ROTATION" FROM FLIGHT 160 WHEN AVAILABLE.  
OTHERWISE FROM FLIGHT 170.

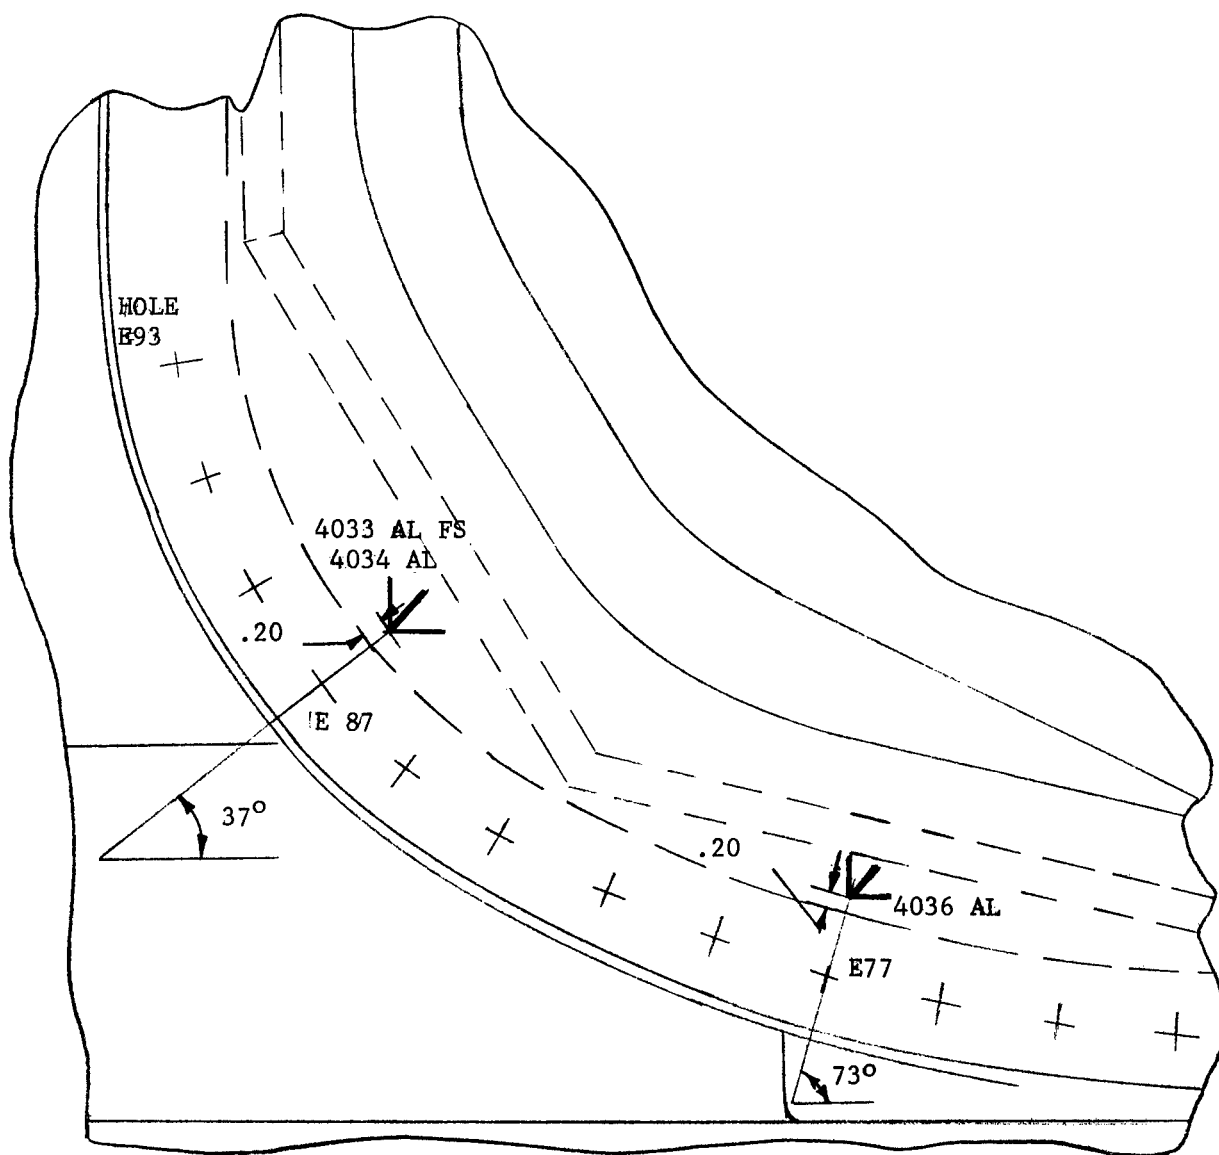
FIGURE 2.1.2-6

At the end of flight 1280, three additional rosette gages were added to the Y<sub>F</sub> 992 bulkhead titanium panel at the lower outboard corner to obtain additional information on stress distributions in the vicinity of a failed Taper-lok fastener. (See Fig. 2.1.2-6.)

At flight 1209, Taper-lok E-87 at the lower outboard corner of the Y<sub>F</sub> 992 bulkhead was found to be failed in the threads. Bolt prying caused by the single shear joints appear to have occurred. Further review of the area showed that for the current math model loads, negative fastener shear margins exist for static ultimate load. It was decided that several rosette strain gages would be added in order to obtain additional stress distribution data. (See Fig. 2.1.2-6 for gage locations.)

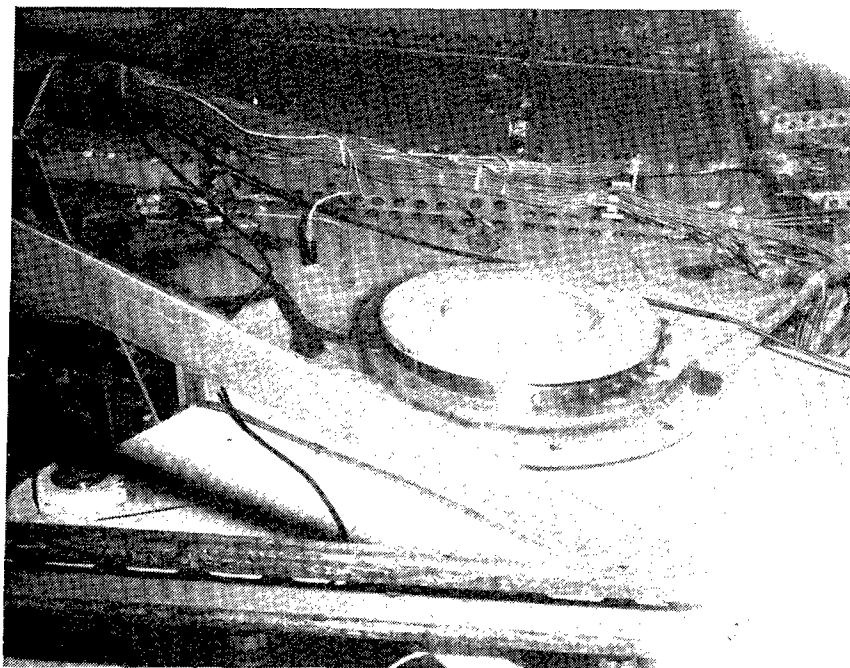
FIGURE 2.2.1-2

RETENTION OF UPPER BUSHING TO PIVOT PIN

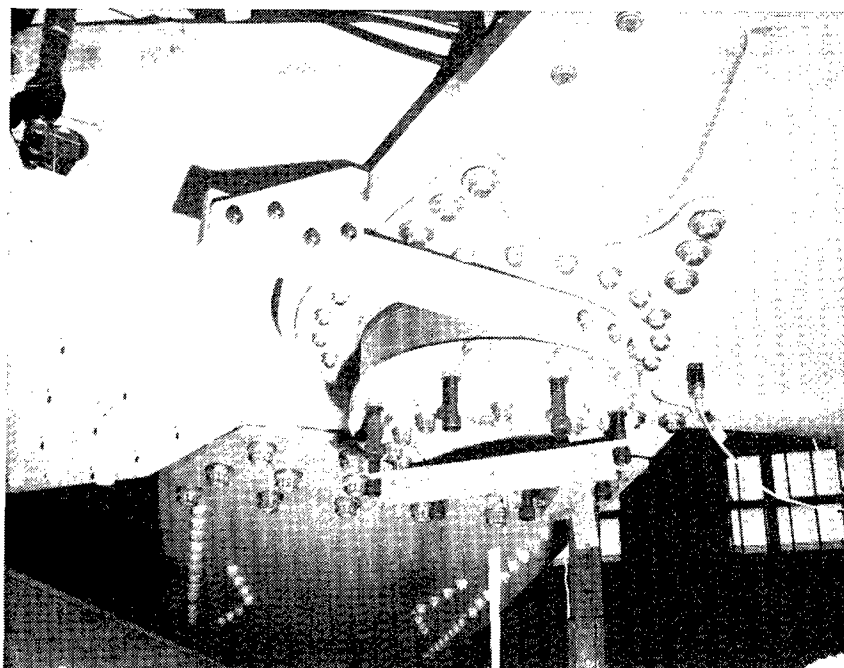
FIGURE 2.2.1-3

RETENTION OF LOWER BUSHING TO WCTS LOWER LUG
